## Journal of Structural Geology

## Structure and Holocene evolution of an active creeping thrust fault: The Chihshang fault at Chinyuan (Taiwan)

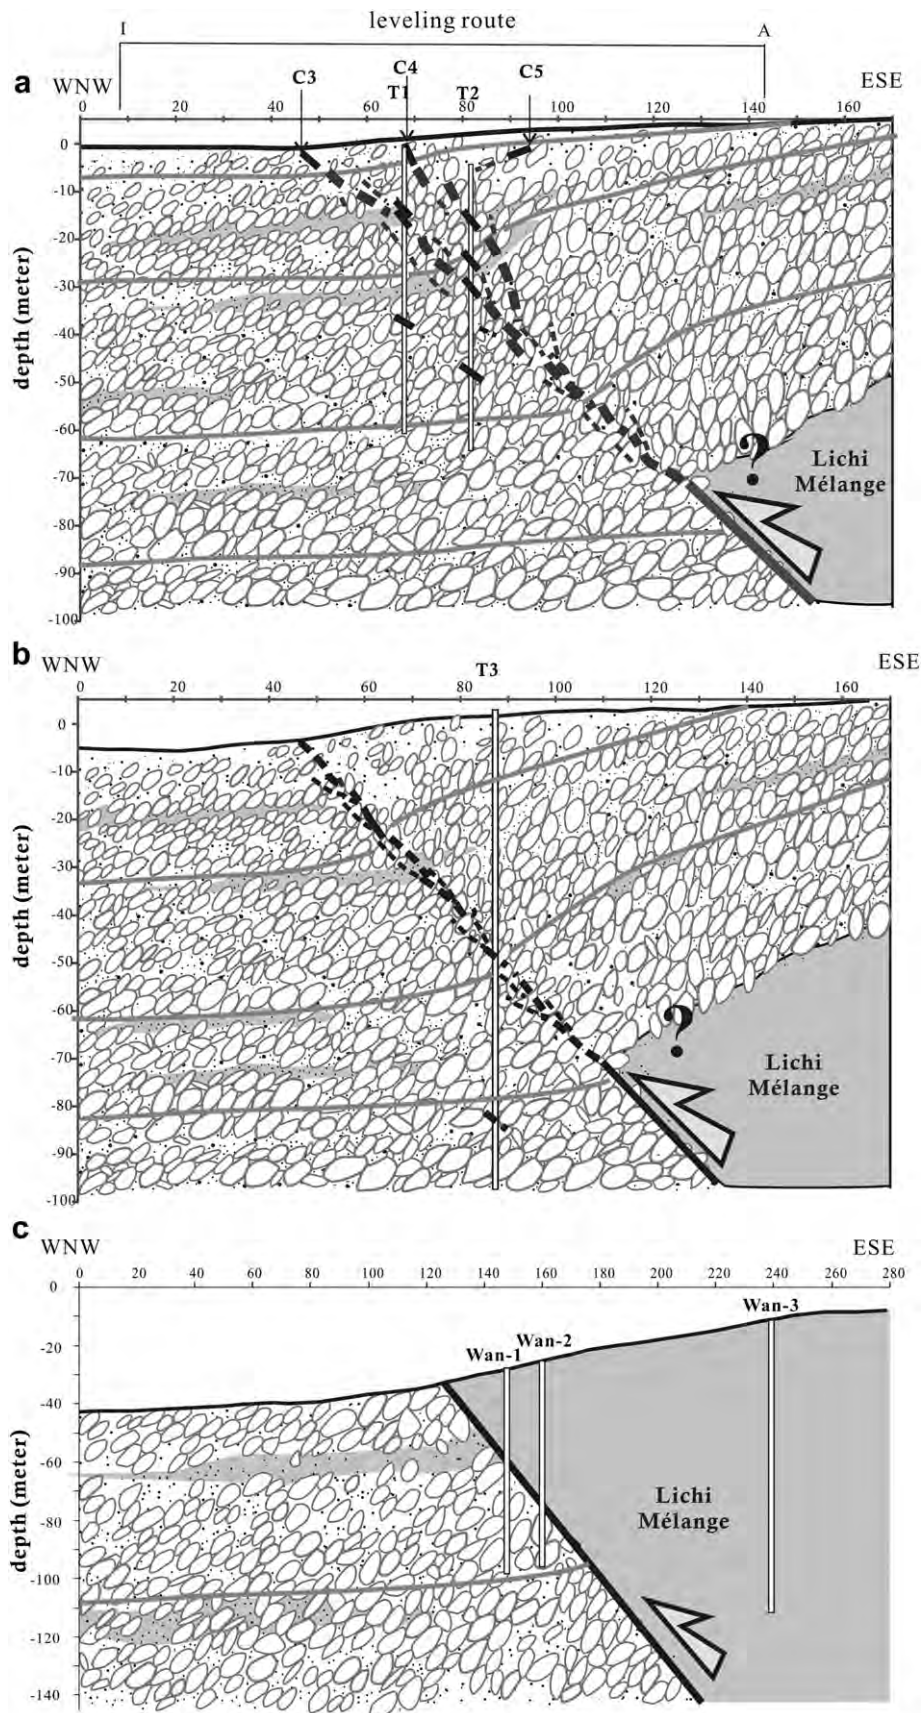
**Fig. 7.** 2-D schematic geological cross-section with fault architecture of the Chihshang fault in the near surface at three different locations. (a) Chinyuan site I, within the alluvial fan of the Chinyuan River, showing a diffused fault zone with a three-branch fault system in the upper 30–40 m. (b) Chinyuan site II, outside of the Chinyuan River channel, showing a single-fault system with a diffused fault zone in the upper unconsolidated deposits. (c) Wanan site, characterizing by a sharp fault zone separating the Lichi mélange to the hangingwall and alluvial deposits to the footwall.

surface fault scarp to the fault at 54 m at the core of T3 to obtain a dip of 45°–50° (Fig. 7b). Based on the observations from the cores and the trenching excavated cross sections at the Observatory (Chu, 2007), the fault zone is generally composed of several faults in a diffused zone instead of a sharp fault plane, which is consistent with our interpretation from core analysis. This outcome is not surprising, considering the facts that the fault is developing within young unconsolidated gravel deposits, which are quite inhomogeneous with relatively hard pebbles surrounded by much softer sand/mud matrix.

In addition to our three boreholes, we examined three nearby boreholes drilled by Central Geological Survey and National Taiwan University (Chen, 2009), about 500 m south of the Chinyuan site in Wanan (Fig. 4a). These three boreholes, Wan-1, Wan-2 and Wan-3, were drilled along a 150-m-long line perpendicular to the strike of the Chihshang fault. Unlike the Chinyuan site, fluvial deposits are absent from the hangingwall in the Wanan site, whereas the Lichi Mélange is present. The 70-m-long core of Wan-1, drilled in the hangingwall about 25 m east of the fault scarp showed that the main fault plane is located at the depth of 29 m with 1-m-thick fault gouge. The main fault separates the Lichi Mélange in the hangingwall from recent alluvial gravels intercalated with fine-grained sand/silt in the footwall (Fig. 7c). The 70-m-long core of Wan-2, drilled about 40 m east of the fault scarp, revealed a similar fault zone at the depth of 46.4 m juxtaposing hangingwall the Lichi Mélange from the recent alluvial deposits to the footwall. The 100-m-long Wan-3 core in the hangingwall and 150 m from the fault scarp exclusively contained the Lichi Mélange and no occurrence of the fault zone. Combining the information from the three boreholes in Wanan, the Chihshang fault has a dip angle of 45–50° at a shallow depth in this area (Fig. 7c).

2004 showed the forelimb of a gentle anticline in the subsurface strata near the primary fault surface trace (Chen, 2009). Combining these data, we interpret the presence of an about 100-m-wide anticline above the main fault at the Chinyuan site (Fig. 7a and b).
