Tectonophysics 333 (2001) 219–240

# Continuous monitoring of an active fault in a plate suture zone: a creepmeter study of the Chihshang Fault, eastern Taiwan

*Keywords:* creepmeter; active fault; fault creep; plate suture

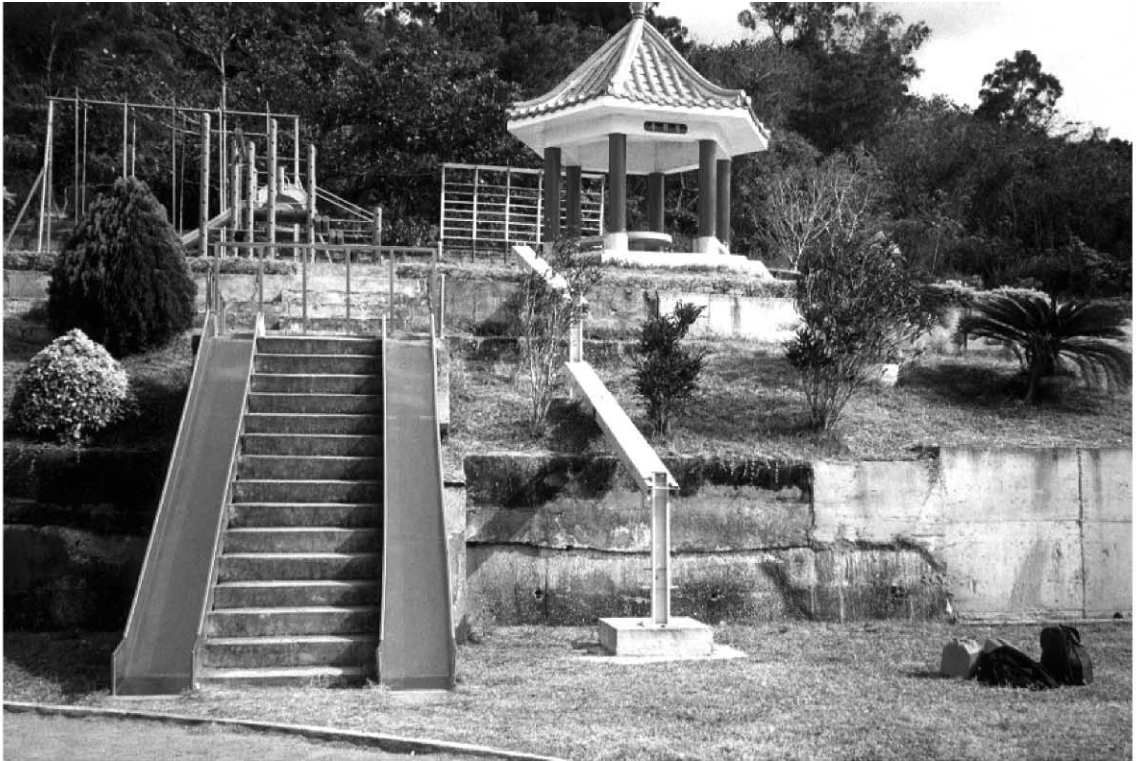
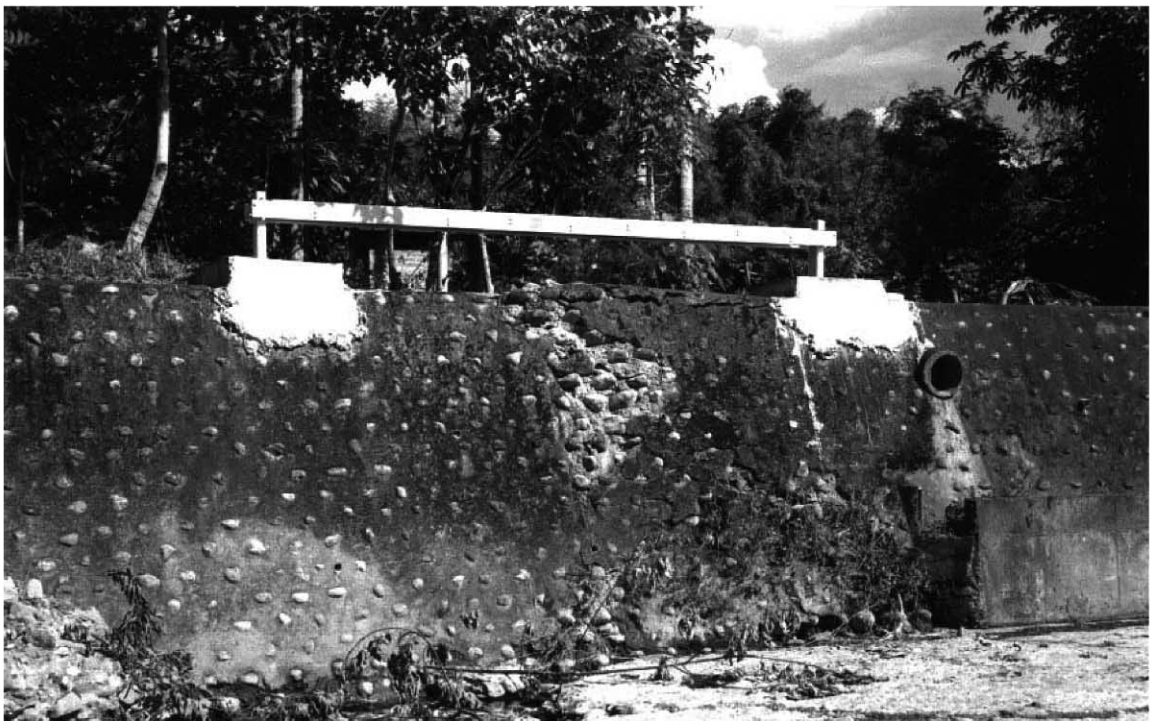
Fig. 6. Photograph of rod-type creepmeter. (a) The creepmeters CHIH001 (the lower one) and CHIH002, having a common pier in the middle, across the active fault zone and aligned subperpendicular to the fault strike at the foot of rugged hills of the Coastal Range in the Tapo School. (b) The creepmeter CHIH004, straddling the surface fractures of the active fault, was installed on the wall of the water channel in the Chinyuan

Two aligned creepmeters (CHIH001 and CHIH002) were installed across the fault zone in the Tapo primary school (Fig. 6a), and three creepmeters were installed across three parallel branches of the fault zone in the Chinyuan village (CHIH003, CHIH004, and CHIH005).

At the Tapo primary school, the creepmeters are straddling the Chihshang active fault with the western pier installed on the flat alluvium deposits (belonging to the Longitudinal Valley) and the eastern pier installed on the inclined slope of the Lichi Mélange (belonging to the Coastal Range). These two creepmeters are aligned and have a common pier (Fig. 6a). The total displacement is given by the sum of the records of the two creepmeters. The fault structure at this site has been accurately known because of the excavation made during wall reconstruction in May 1997, as described by Chu et al. (1998). Although there is no doubt about this location of the active Chihshang Fault based on field studies, the displacement at Tapo may be influenced by both the well-known instability of the Lichi Mélange and the down slope sliding of the hill, east of the school (see discussion in Angelier et al., 1999). For this reason, the results obtained at this locality of the Tapo school must be considered with caution despite the spectacular aspect of fault displacement at this site. To this respect, in the forthcoming discussion, the interest of comparing the Tapo data and the Chinyuan data will be highlighted.
